Concerns regarding mid-water transport of oil from well

Ian MacDonald Presented to the Florida Oil Spill Academic Task Force <u>http://oilspill.fsu.edu</u>

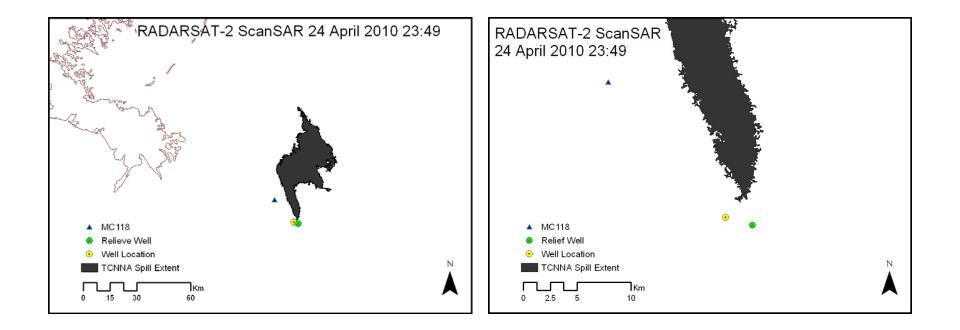
Oil released from the Deepwater Horizon well was drifting north during early days after the accident. The relief rig (Development Driller III) has been positioned near the damaged well (2.5 km), but outside the apparent plume of rising oil. MC118 is a site that harbors a known community of deepsea corals. The spill extent data were taken three days after the accident. Presently the spill covers the entire area.

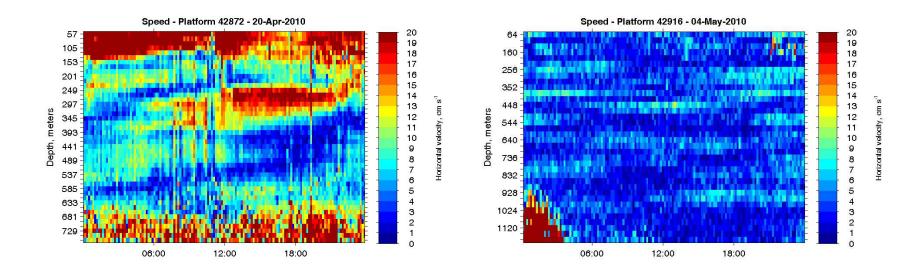
The Deepwater Horizon (42872) and the Development Driller III (42916) were both outfitted with acoustic Doppler current profilers (ADCP), which measure the currents at different depths below the rig. These data are automatically reported to shore-based observers. The current profiles would be immensely valuable for modeling the probable trajectory of oil to the surface and possible mid-water transport of oil to which dispersant has been added. Comparison of equivalent speed profile records from the two instruments indicates that the one presently on the Development Driller (right) is not properly configured and is not producing useful data.

Experts who do regular QA/QC on these data concur. Steve DiMarco (Texas A&M Univ. Oceanography Dept.): The speeds are tiny compared to climatology, also the directions vary way too much to be believable. I can see little diel structure in the backscatter in the upper 250 m.

- The on-scene coordinator needs to check the ADCP on the Development Driller III. A phone call to technicians on land might rectify the situation
- If possible, an up-looking ADCP should be installed on one of the on-scene ROVs. This instrument could readily be configured to send its data to the ship in real time.

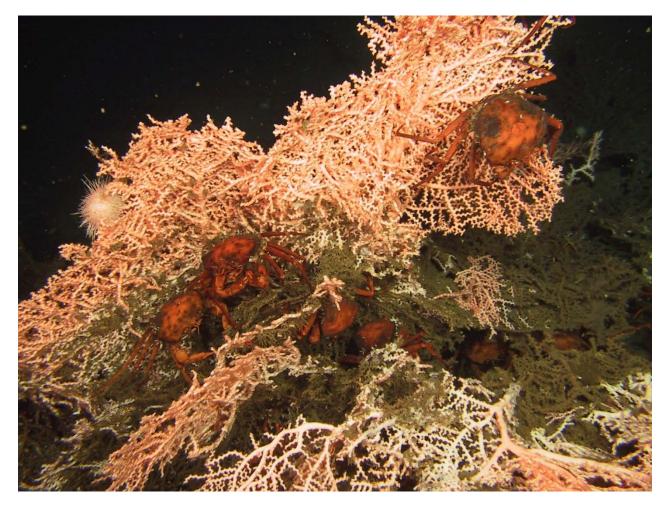
Madrepora coral at MC118: This colony of corals is located ~10 km from the leaking well. Injection of dispersants in oil released at the seafloor may lead to further entrainment of oil plus dispersant to this site. Current profiles would assist in predicting this possibility.
